*Appendix F –  
Borescope Investigation of Pier E2 Rods  
Holes, SMR Reports (2011 and 2013)*

Self-Anchored Suspension Bridge

Borescope Investigation of Pier E2 Rod Holes – 2011

Borescope Investigation of Pier E2 Rod Holes – 2013

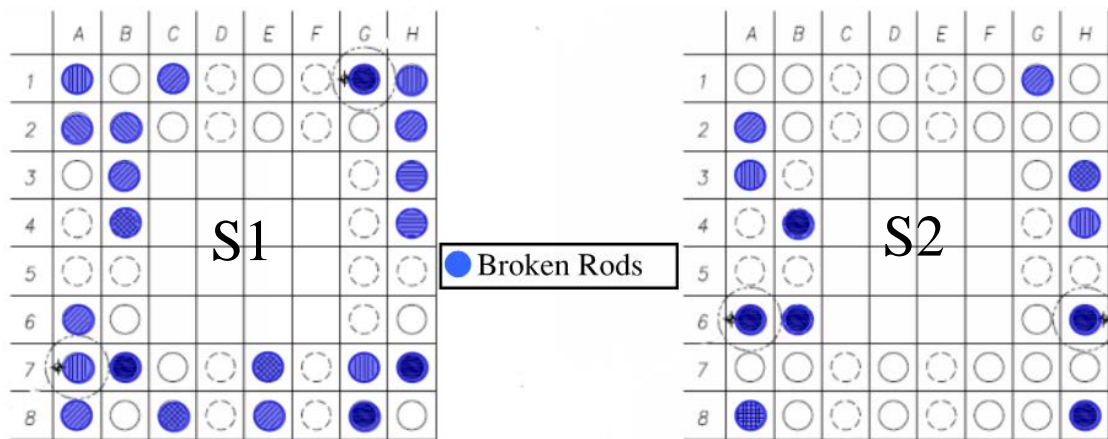
**Figure 1: Locations of Failed Rods in Shear Keys S1 & S2**

Once the grouting was complete, in Mar. 2013, thirty-two (32) of the shear key anchor rods fractured shortly after tensioning. The specific rods are highlighted in **Figure 1**. The top portions of the rods were extracted in segments for fracture analysis. It was not possible to retrieve the bottom fracture surfaces. The Department requested that METS investigate the interior of the rod holes with a borescope to evaluate the in-situ conditions and provide images of the fracture region.
